## 2. MAINTENANCE OF PROJECT FEATURES

### 2.1 Introduction

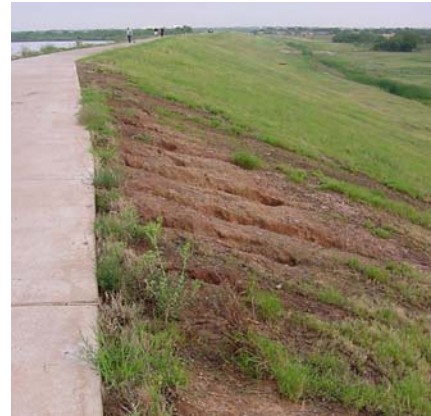
**Figure 2.1** *UNACCEPTABLE erosion of levee slope. (TX)*

There are several types of erosion that effect FCWs. For example, the slopes of any embankment can become eroded from rain runoff, as shown in Figure 2.1 or by embankment overtopping, as in Figure 2.2. Depending on the extent of the erosion, the level of protection provided by the FCW can be significantly reduced. In cases of embankment overtopping during a flood, there may be a total failure of the structure.

All erosion gullies like those pictured in 2.1 need to be repaired to prevent further erosion and more significant damage during high water. The ground should be scarified and backfilled with the same type of material that the levee is made of. The backfill material should generally be placed in 6 inch layers and compacted mechanically or by hand, in order to restore the original shape of the levee. Additionally, since this erosion is typically a reoccurring problem, something should be done to improve the drainage and prevent further erosion in the area. Consideration

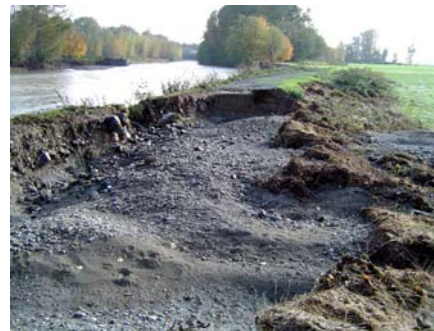
**Figure 2.2** *Flood damage. (WA)*

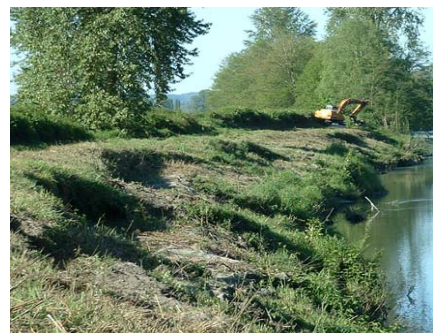
**Figure 2.3** *Slope failure on bank protection project. (WA)*

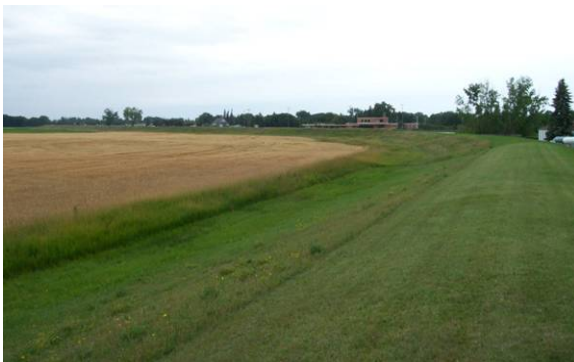
**Figure 2.4** *ACCEPTABLE.* Landowner has not encroached on levee easement area and has stayed back 10 - 15 feet. (MN)

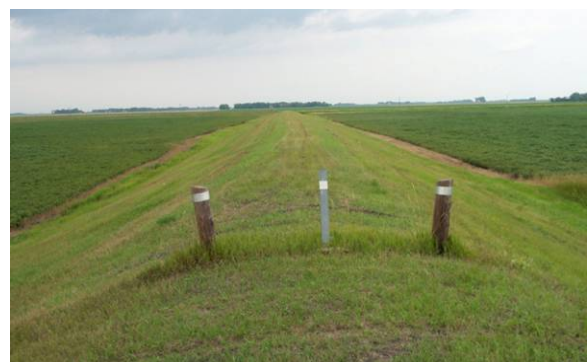
**Figure 2.5** *MINIMALLY ACCEPTABLE.* Field encroaches on levee easement. The landowner has tilled the soil right to toe of the levee, and was requested to stay back at least 10 feet. (ND)

Excavations, structures, or other obstructions present within the project easement area are generally prohibited. Fencing that prohibits access along the crown of the levee is prohibited. Where access control is needed, the public sponsor should install gates that will allow continued access along the crown of the levee for surveillance and flood fight activities. The Corps may make certain exceptions to this rule, provided the encroachment does not impact the operation, maintenance, or structural integrity of the project. Figures 2.5 through 2.14 are examples of common encroachments that should not be permitted.

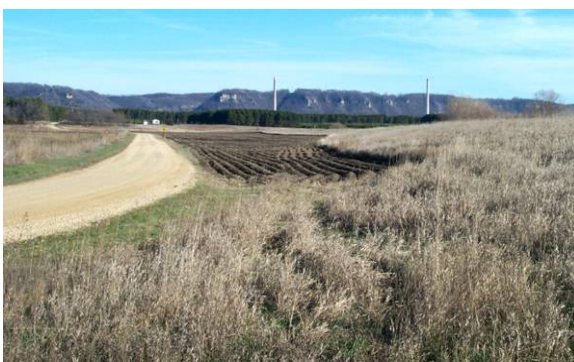
**Figure 2.6** *UNACCEPTABLE* levee encroachments. This landowner tilled near one third of the way up the landward levee slope. (MN)

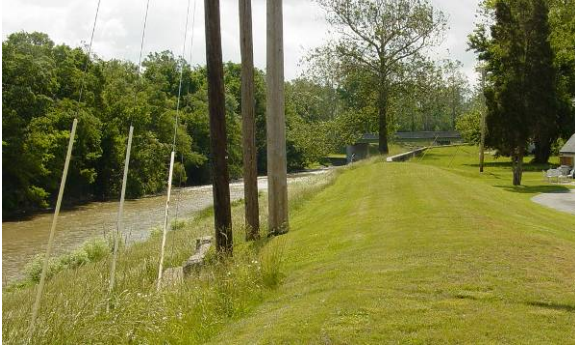
**Figure 2.7** *UNACCEPTABLE levee encroachments. Utility poles in levee embankment. (IN)*

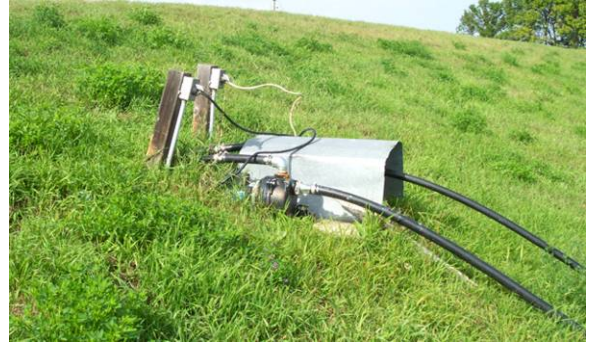
**Figure 2.8** *UNACCEPTABLE encroachment. Piping for lawn irrigation system drilled through levee without approval. (ND)*

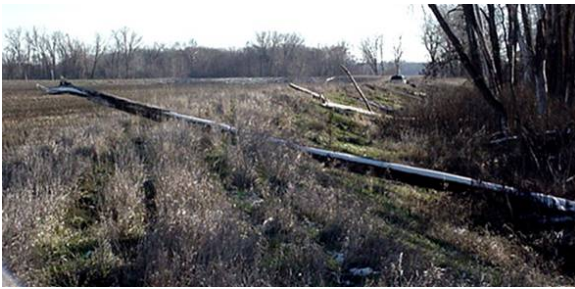
**Figure 2.9** *UNACCEPTABLE encroachments on earthen levee. Fallen woody debris requires removal. (KS)*

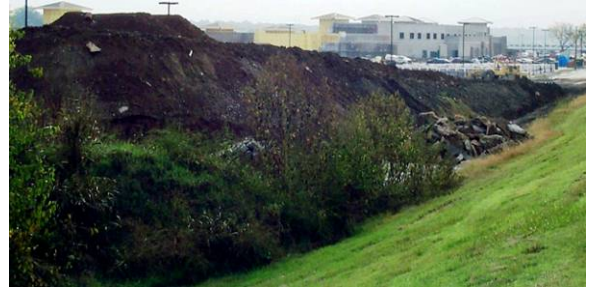
**Figure 2.10** *UNACCEPTABLE, unapproved encroachment. Material stockpiled against the levee. (OK)*

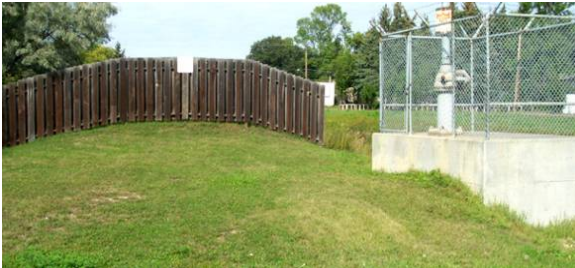
**Figure 2.11** *UNACCEPTABLE encroachment. Residential and rural fences crossing the levee. (ND)*

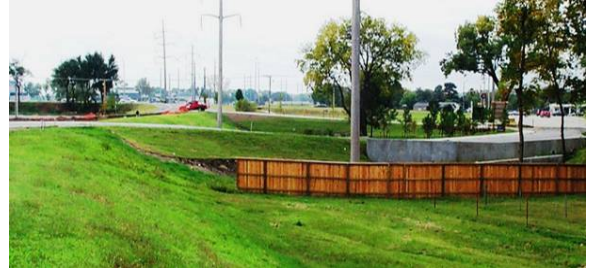
**Figure 2.12** *UNACCEPTABLE, unapproved encroachment on levee easement (fencing). (OK)*

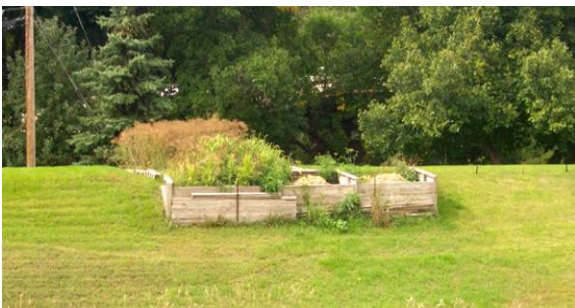
**Figure 2.13** *UNACCEPTABLE encroachment. Gardens and compost bins located on levee crest and riverward slope. (ND)*

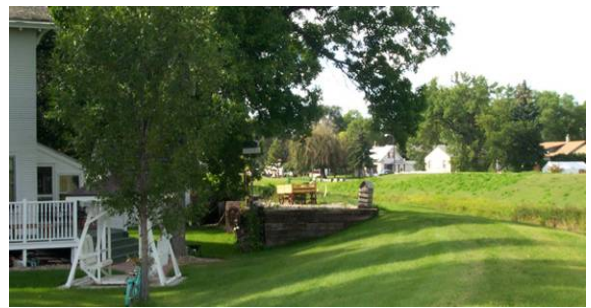
**Figure 2.14** *UNACCEPTABLE encroachment. Patio construction using railway timbers and fill without approval. (ND)*

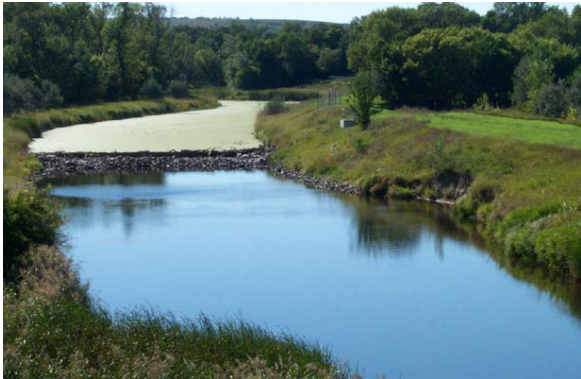
**Figure 2.15 UNACCEPTABLE.** Slope failure and erosion caused by inadequate channel bottom and side slope protection. This was a direct result of bottom scouring that undercut the levee slope and erosion caused by turbulent flow at the end of the bank protection. (ND)

Some earthen materials tend to become saturated with water very easily. When this happens, they lose stability and can't support their own weight. If a stream or river embankment is composed of these materials, the embankment will slump off and move down the slope into the river, causing a bulge at the base of the slope. When river banks break down like this, they are said to have slope stability problems and need to be repaired. Slope failures can lead to serious problems, especially if the failure occurs near a levee or floodwall. Figures 2.15 through 2.17 show examples of slope stability problems.

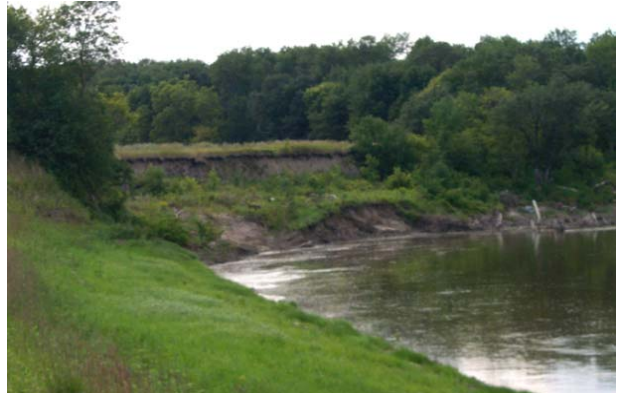
**Figure 2.16 UNACCEPTABLE.** Slope failure and erosion on a channel improvement project. (MN)

- a. Wide deep cracks that parallel the riverbank or levee crest. In the case of levees, these cracks may also extend down the slope of the levee.
- b. Vertical movement of the material along the crack. Remember that this movement may be very obvious like in Figures 2.16 or 2.17, or very subtle if the stability problem is just starting to develop.
- c. If the slope has slumped or is starting to slump, examine the area along the toe of the embankment. In many cases there will be a noticeable bulge in the slope or riverbank.

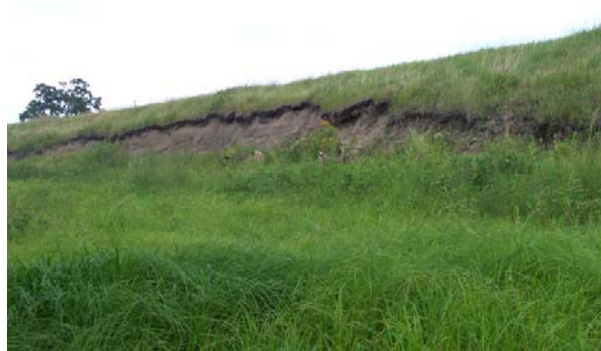
**Figure 2.17 UNACCEPTABLE** earthen embankment failure. (MN)

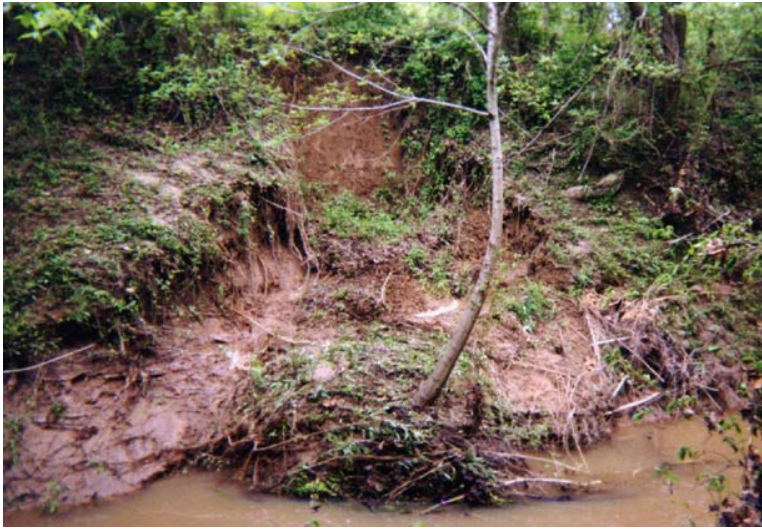
A related slope failure/ stability problem involves trees growing on or near the channel or levee slopes. It's very important to prevent tree growth near levee or channel embankments, because when the roots of these trees decay they leave voids in the soil, which allow water to quickly saturate the slope and cause a slope failure. Trees can also be uprooted and deflect flood flows into the embankment, accelerating the erosion of the bank.

**Figure 2.18** *Classic picture of a tree causing slope failure. (WA)*

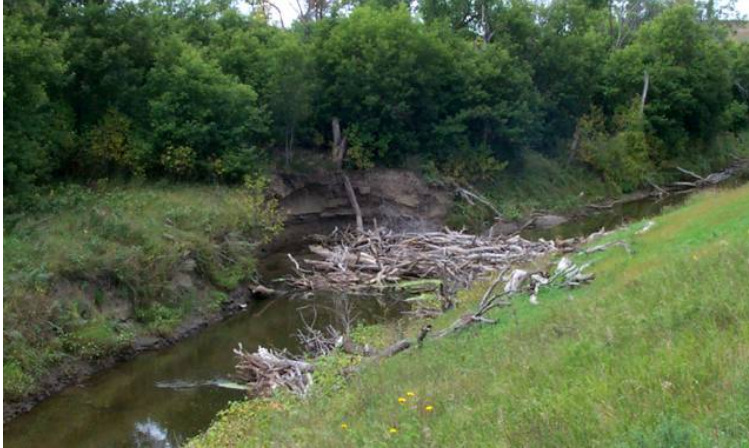
**Figure 2.19** *UNACCEPTABLE erosion of river channel, caused by a log jam. (ND)*

channel, it can deflect the water towards the channel bank, causing significant damage to the FCW. Figure 2.19 shows the result of what started out as a beaver dam that was not removed, which expanded into a log jam. Before this log jam was removed, both the inside river bank and the levee experienced severe bank erosion. Log jams have endangered bridges and railway crossings, and they lead to higher flood crest elevations upstream of the obstruction.

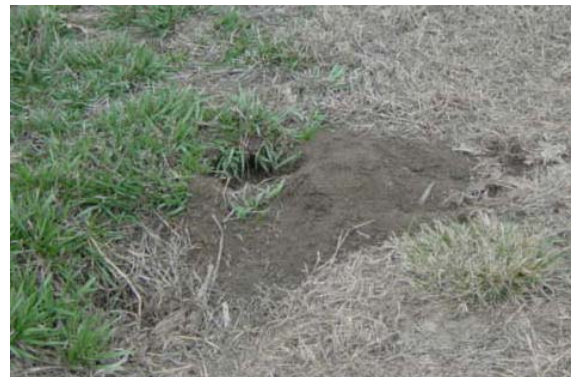
**Figure 2.20** *Animal burrow in a levee. (IA)*

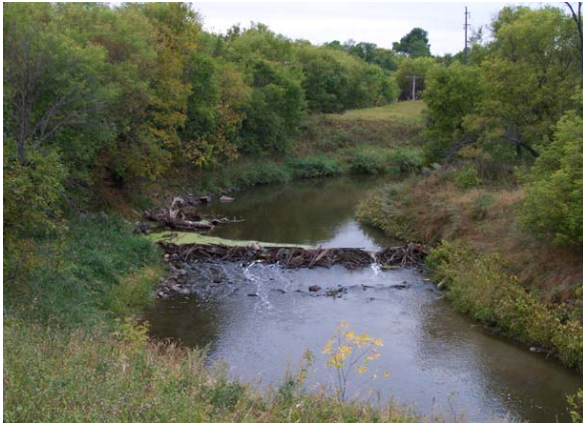
**Figure 2.21** Beaver dam. Such dams can stop flow within the channel and cause erosion to the channel banks. Sponsors are encouraged to remove beaver dams ASAP. (ND)

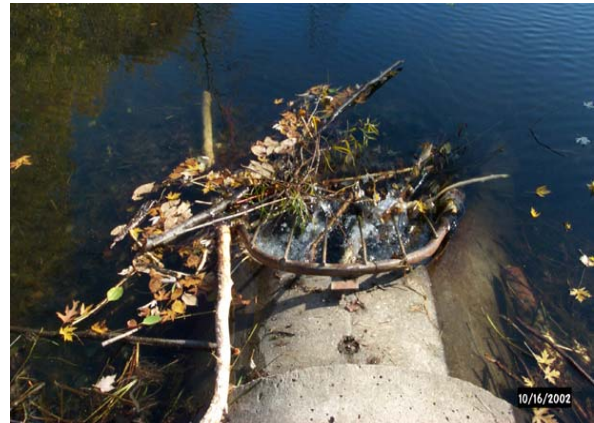
**Figure 2.22** Beavers attempting to block the culvert passing through a gated embankment. (MN)

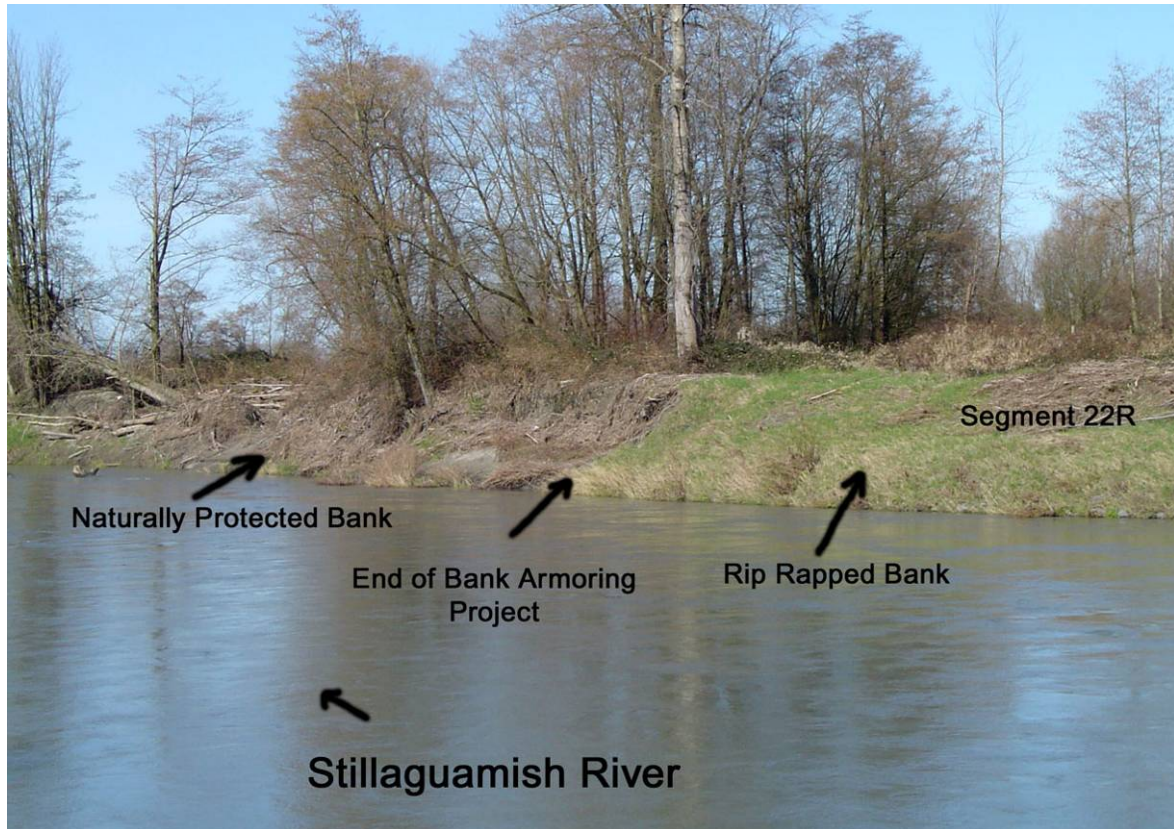
**Figure 2.23** Flood damage on a naturally protected bank, as compared to damage on an adjacent bank which was protected with riprap. (Note that even though the riprap clearly protected the area during the flood, if it was observed an inspection it would have probably been rated Minimally Acceptable because the grass would have prevented an inspector from properly examining the riprap.) (WA)

As shown in Figure 2.23, riprap can be a very effective method for protecting a riverbank or flood control feature from erosion. However, if the riprap protection is not placed correctly, it can cause eddy currents to erode unprotected areas of the bank upstream or downstream of the project, as shown in figure 2.24.

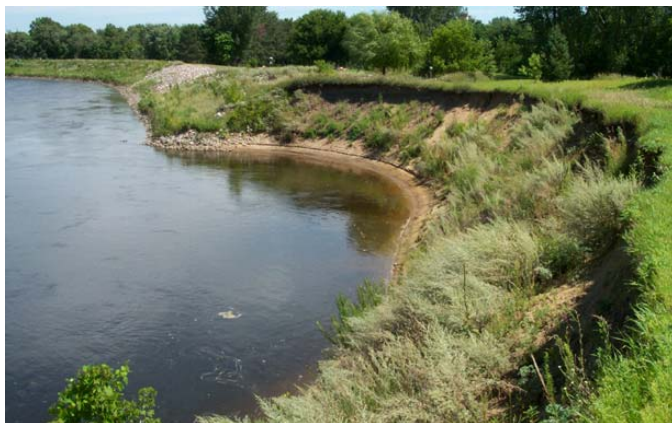
**Figure 2.24** Channel erosion located at the upstream end of a flood control levee protected by riprap. Erosion caused by riprap protection and eddy currents. (MN)

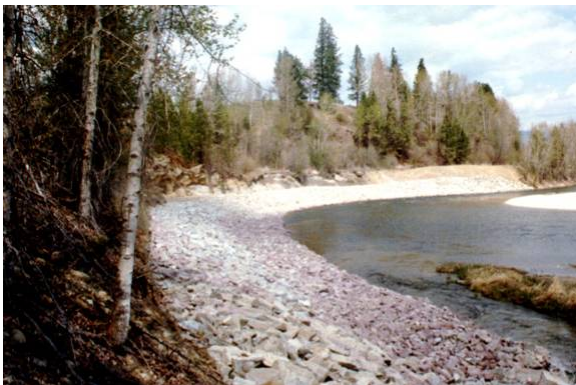
**Figure 2.25** *ACCEPTABLE* riprap for erosion control. (MT)

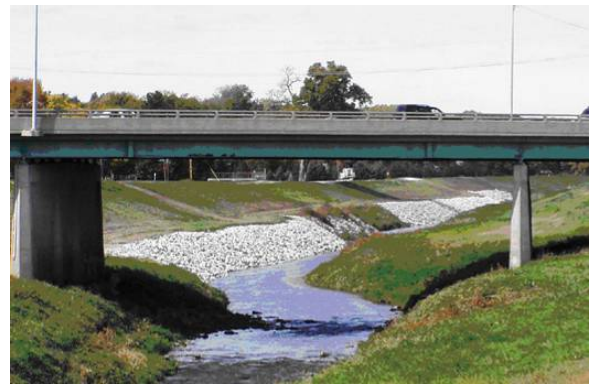
**Figure 2.26** *ACCEPTABLE* riprap for erosion control. (NE)

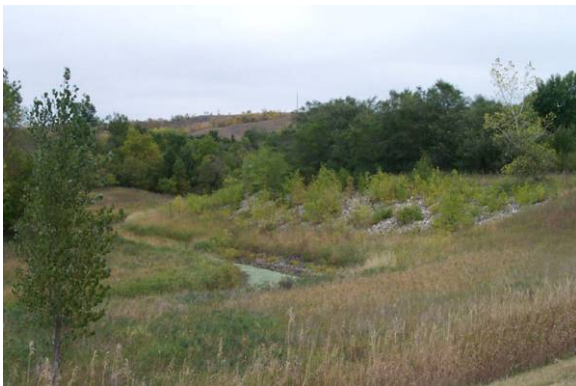
**Figure 2.27** *MINIMALLY ACCEPTABLE*. Trees and saplings are becoming established within riprap-protected areas and along the lower portions of the river channel, and must be removed. (ND)

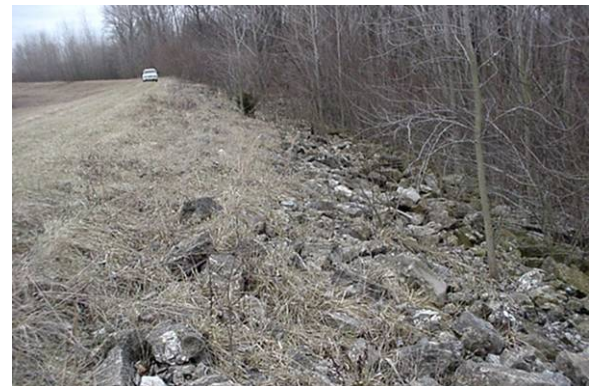
**Figure 2.28** *UNACCEPTABLE*. Tree and sapling growth is well established within the riprap protection on an earthen levee. This overgrowth must be removed. (MO)

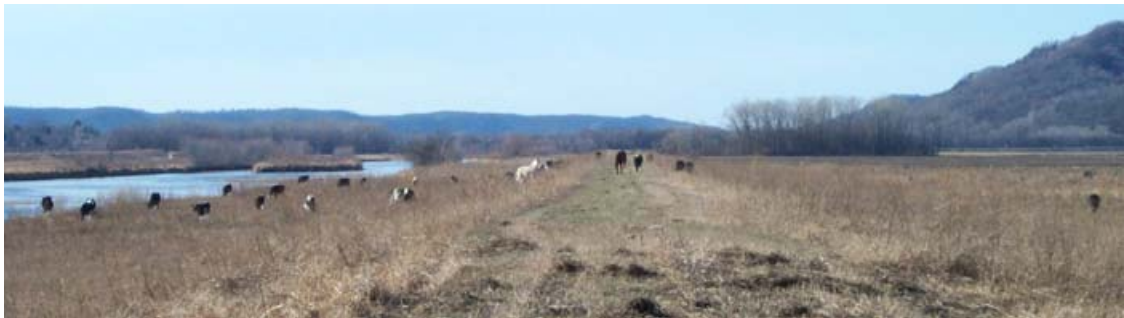
**Figure 2.29 MINIMALLY ACCEPTABLE.** This photo shows cattle grazing on the levee. Cattle typically don't harm the sod cover to the extent that sheep or other animals do. In this case, the landowner and the public sponsor were informed of the Corps' policy that grazing is not permitted on levees or within the levee easement area.

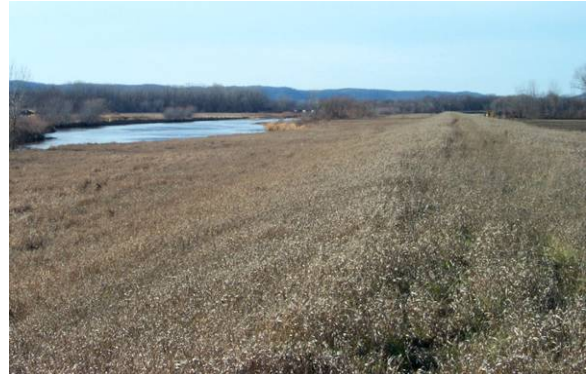
**Figure 2.30 UNACCEPTABLE** levee with knee-high grass, making visual inspection nearly impossible. (MN)

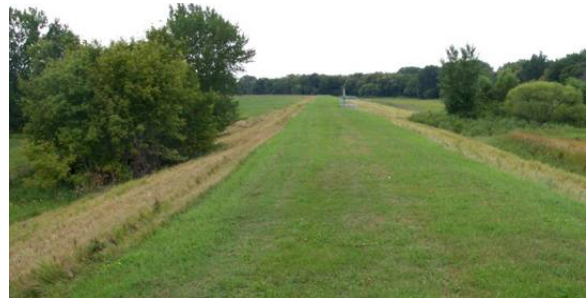
**Figure 2.31 UNACCEPTABLE.** Levee is mowed but trees and longer grasses within levee easement area. Trees are greater than 2" in diameter. (MN)

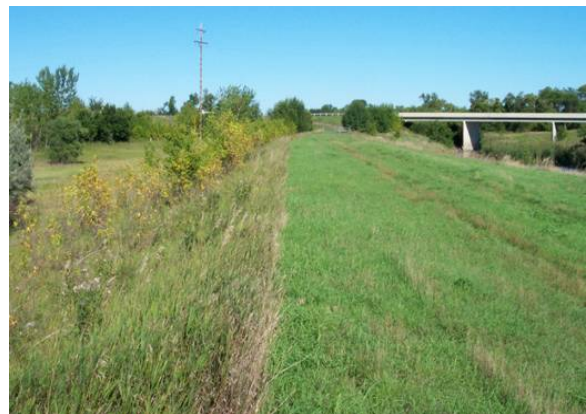
**Figure 2.32 UNACCEPTABLE** long grasses and trees on levee side slopes. (ND)

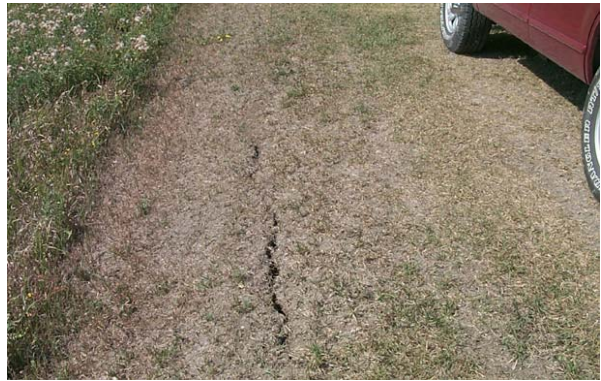
**Figure 2.33** *ACCEPTABLE* cracking in clay levee with shrinkage cracking caused by dry conditions. (MN)

during long periods of drought they may extend as much as two feet into the levee. These cracks can run longitudinally or transverse to the levee, as in Figure 2.33, or may appear as blocks as shown in Figure 2.34. If the cracking becomes excessive, it needs to be corrected even if the levee appears to be stable. It's important that you contact your local Corps district office for guidance on how to repair cracks observed in your levee.

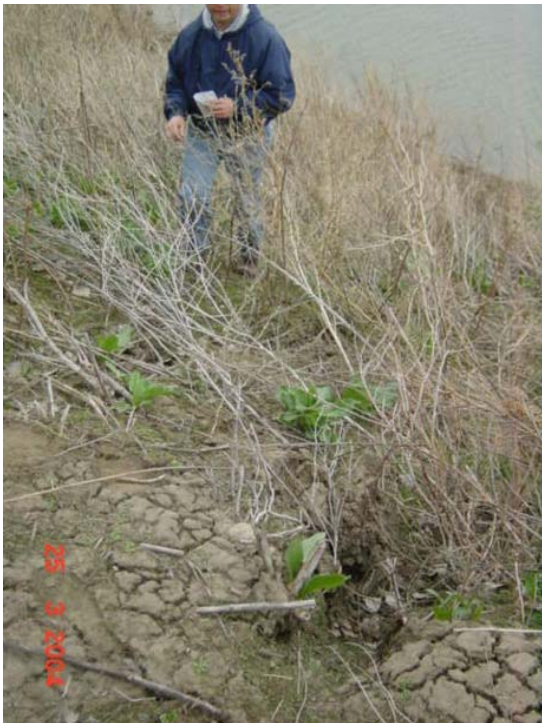
**Figure 2.34** *UNACCEPTABLE* cracking with landside pooling, Whitehead Levee Project, (IA)

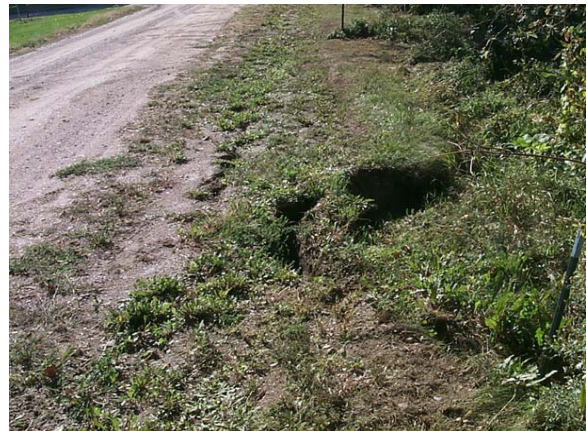
**Figure 2.35** *UNACCEPTABLE* embankment cracking and slope failure. This photo shows what started out as cracking along the crest of the embankment and quickly developed into a slope failure. All cracking located on a levee or riverbank must be closely monitored. (MN)

It's important to closely monitor and evaluate all visible areas of cracking on a levee or riverbank, to ensure they don't develop slope stability problems as shown in Figure 2.35 and discussed in section 2.4. Cracks in a levee develop when the levee material is saturated with water and when it is overly dry. Clay, like most impervious materials, will shrink as it dries and re-expand when wet. Clay levee surfaces tend to shrink and expand slightly, and some cracks in the surface of the FCW are to be expected. Shrinkage cracks are generally narrow and shallow, not extending more than more than a few inches into the levee, but

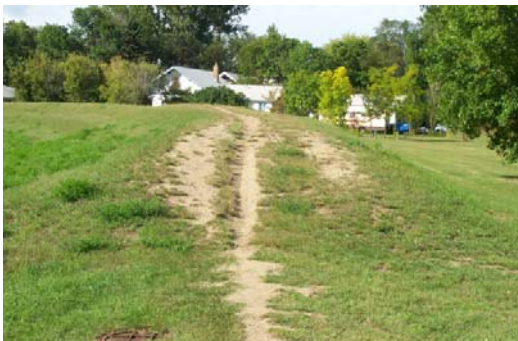
**Figure 2.36** *MINIMALLY ACCEPTABLE* levee rutting caused by pedestrian and bicycle traffic. (ND)

Figures 2.36 through 2.39 show common ruts that can hold water on access roads and levees.

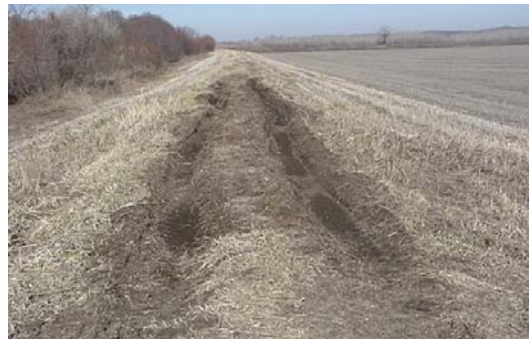
**Figure 2.37** *UNACCEPTABLE* ruts in levee crown require fill. (MO)

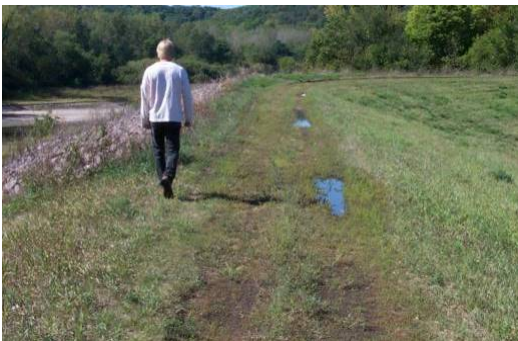
**Figure 2.38** *MINIMALLY ACCEPTABLE* ponded water along a levee crest. (MN)

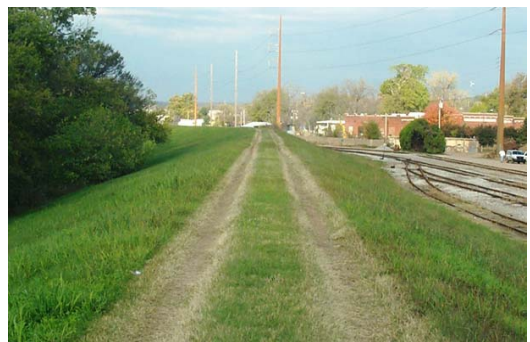
**Figure 2.39** *UNACCEPTABLE* rutting in levee. (OK)

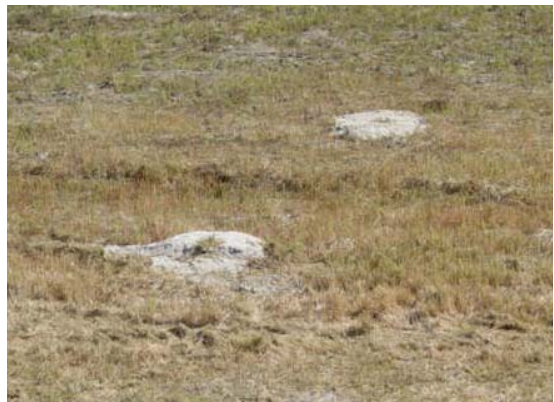
**Figure 2.41** *Evidence of sandboils. (IN)*

Sandboils and seepage problems are not generally identified during routine inspections because these problems typically only appear under high water conditions. However, if sandboils or continuously saturated soils (not caused by ponded water or poor drainage) are observed on the landward side of the levee or floodwall under low water conditions, regardless of their size, they will likely become serious problems under high water conditions. Sandboils and underseepage is a serious problem that should not be taken lightly.

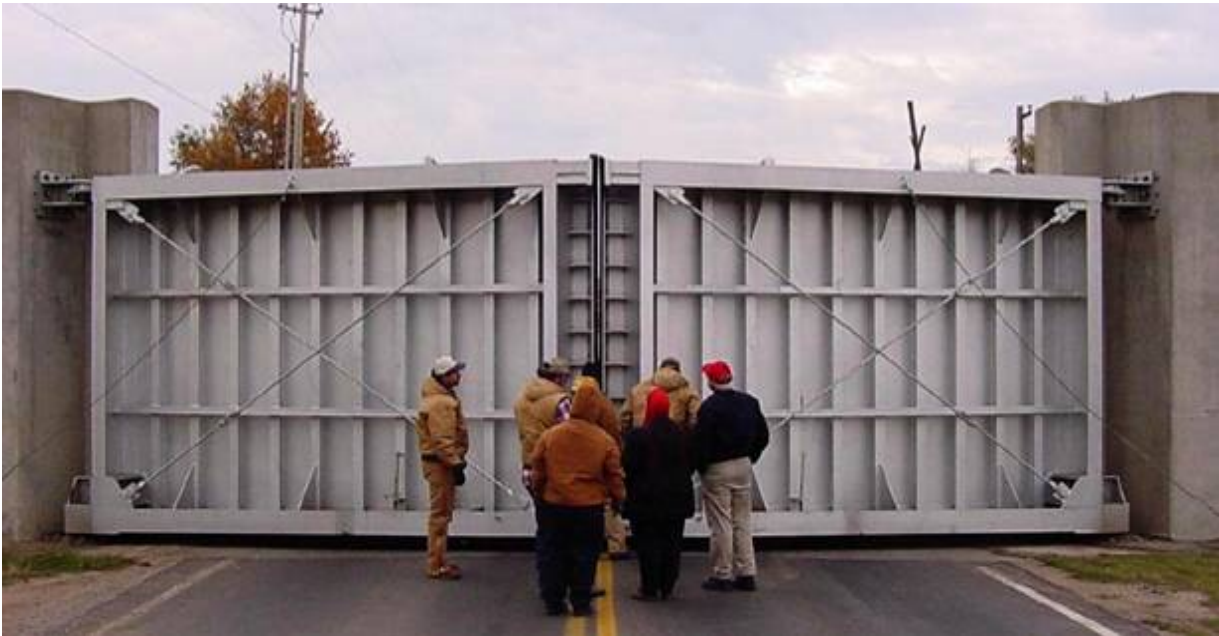
**Figure 2.42** *ACCEPTABLE floodgate in a levee. (KS)*

Closure structures must be in good repair. Placing equipment, stoplogs, sandbags, and other materials must be readily available at all times; stored nearby on the protected side of the levee, or stored on a trailer for quick transportation to the site. It's important that all components are clearly marked and that installation instructions and related procedures are readily available. You should regularly check your inventory of all components of the closure structure to ensure that stoplogs and other components will be there when you need them. Note that when aluminum stoplogs are stored, they should be supported along their entire length so they don't deform during extended periods of storage.

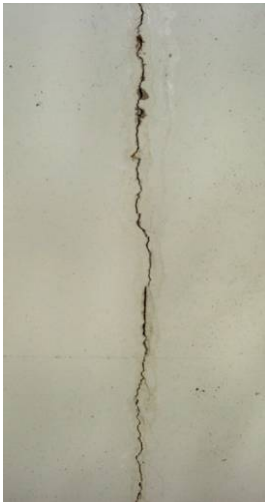
**Figure 2.43** *MINIMALLY ACCEPTABLE* 1/8<sup>th</sup> inch crack extends through concrete floodwall and needs to be sealed to prevent further damage. (MN)

Visible cracking, scaling, or spalling are signs of concrete movement and stresses within the concrete. Cracks in concrete walls that aren't repaired are subject to freeze / thaw damage, which widens the gap and leads to additional spalling of the concrete. When examining any concrete flood control structures, spalling, scaling, or cracking should be very minimal. Figures 2.43 through 2.47, on the following page, show various degrees of cracking, spalling, and scaling.

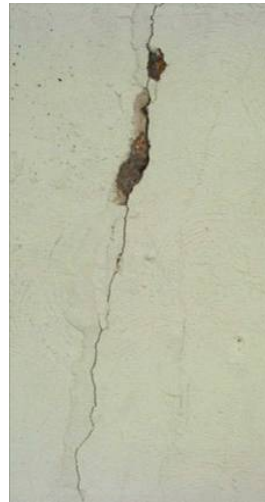
**Figure 2.44** *MINIMALLY ACCEPTABLE* Vertical floodwall crack with spalling. The rating for this particular crack is Minimally Acceptable because the crack is still tight but there is some spalling occurring as well. (MN)

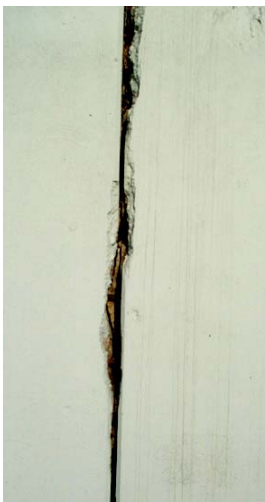
**Figure 2.45** *UNACCEPTABLE* exposed rebar. Monolith joint separation with exterior spalling along the joint and interior spalling in the area of the rebar. (MN)

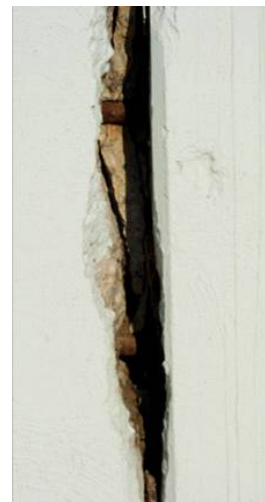
**Figure 2.46** Detail of the crack in Figure 2.45, showing the exposed rebar that tied the two monoliths together. (MN)

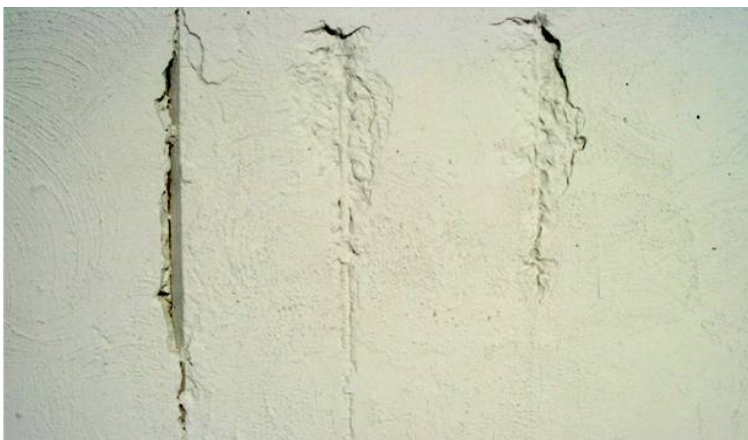
**Figure 2.47** *MINIMALLY ACCEPTABLE* floodwall. Exposed surface rebar resulting from poor construction practices. The public sponsor has painted over the rebar in an attempt to keep it from rusting. (MN)

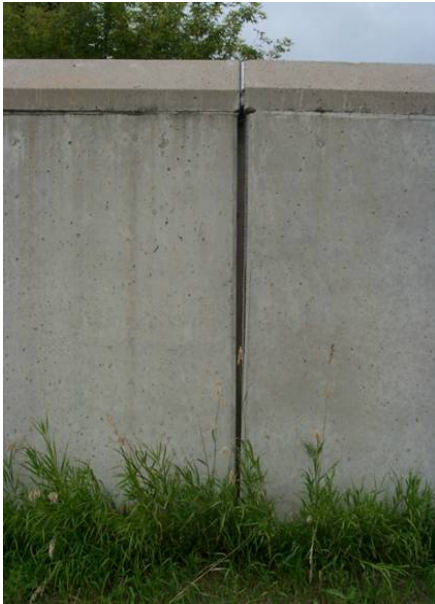
**Figure 2.48** *MINIMALLY ACCEPTABLE* floodwall. Monolith joint separation caused by settlement, no landward or riverward tilting. The opening is about 3 inches wide at the top but the rubber joint sealer is still intact and undamaged. This joint has since been repaired by bolting another joint sealer on the both sides of the wall and filling the void with an expandable joint sealer. (ND)

If soil conditions were poor prior to construction or if there has been inadequate soil compaction, concrete structures (floodwalls, pump stations, and gate wells) will frequently show signs of settlement. As the structure settles it may begin tilting in the lateral or transverse directions, settle vertically, or may even begin to slide downhill, if constructed on a slope. As the pressure within the concrete builds cracking and large spalls will develop. If the movement is considerable like that shown in Figures 2.48 and 2.49, a licensed engineer should be contacted to determine the best approach to correct the problem, or to closely monitor the structure during high water to avoid a structural failure.

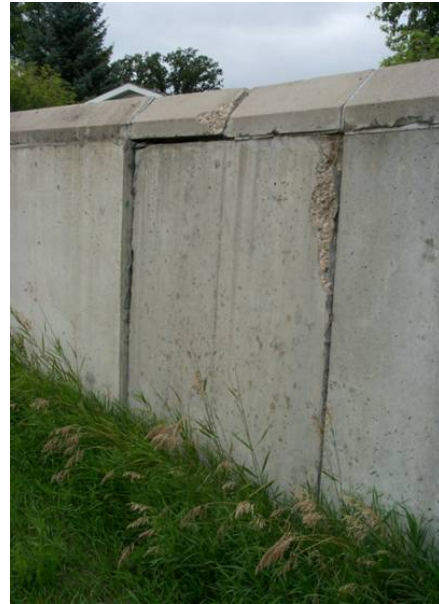
**Figure 2.49** *UNACCEPTABLE* monolith movement in floodwall. The monolith shown in the photo has tilted about 6 inches riverward as well as vertically. Note the movement when compared to the adjoining monolith and the top cap. As the monolith moved considerable spalling has occurred along the joint. This project is monitored very closely during flood events. (ND)

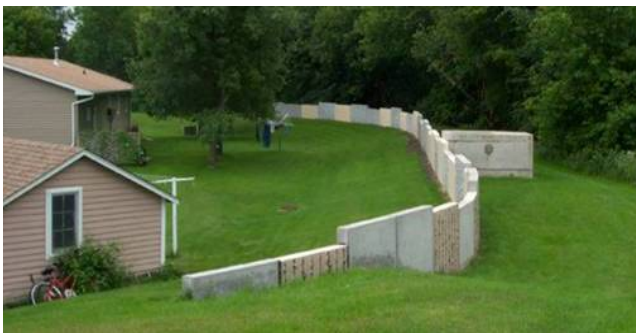
**Figure 2.50** *ACCEPTABLE*. decorative floodwall is in straight alignment, with no tilting or spalling, and all joints are tight together. (MN)

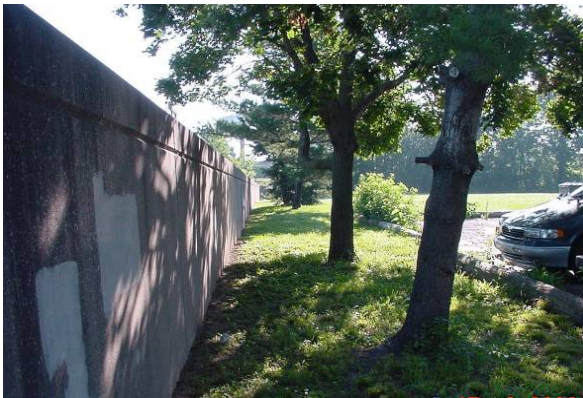
**Figure 2.51 UNACCEPTABLE.** Trees growing too close to floodwall. (KY)

Vegetation must be removed from both sides of floodwalls for maintenance, flood fighting activities, and to protect the floodwall from damage from roots. Roots under a floodwall can greatly accelerate seepage rates during high water, increasing the chance of sandboils on the landward side and potentially leading to the failure of the structure. For these reasons, you should maintain a zone extending 2.5 meters (8') beyond both the underground toe and heel of the floodwall, keeping it free of everything but grass or sod, or possibly riprap on the riverward side. Since the floodwall may have been constructed in the shape of an inverted T, the underground toe and heel may extend several feet past the visible base. Additional guidance on landscaping around levees, floodwalls and embankment dams can be found in EM 1110-2-301, as referenced in Chapter 1.

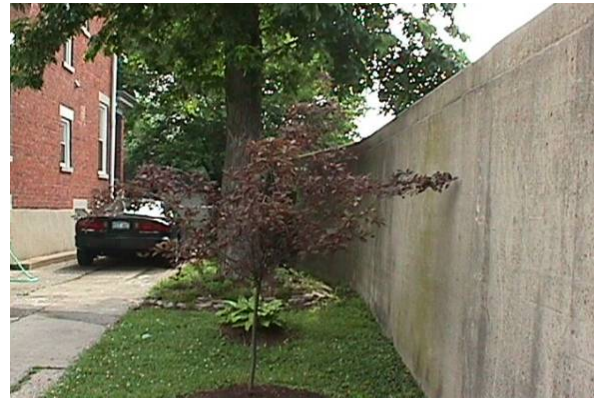
**Figure 2.52 UNACCEPTABLE.** Trees growing too close to floodwall. (KY)

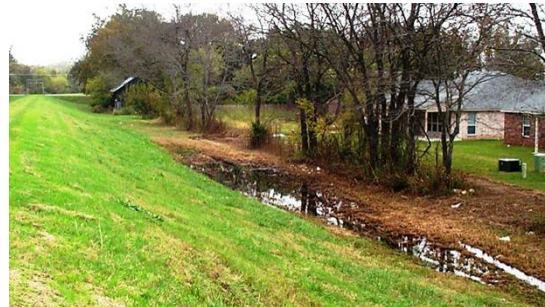
**Figure 2.53 UNACCEPTABLE interior drainage** at the toe of an earthen levee. (OK)

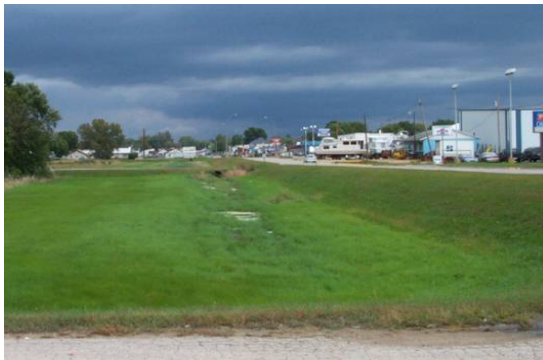
**Figure 2.54** *ACCEPTABLE interior drainage channel. (IA)*

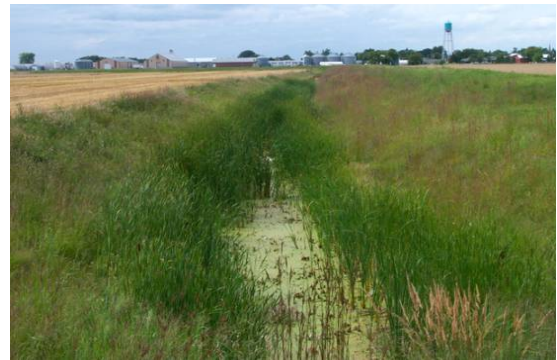
**Figure 2.55** *MINIMALLY ACCEPTABLE vegetation (cat tails and bull rushes) in interior drainage ditch. (MN)*

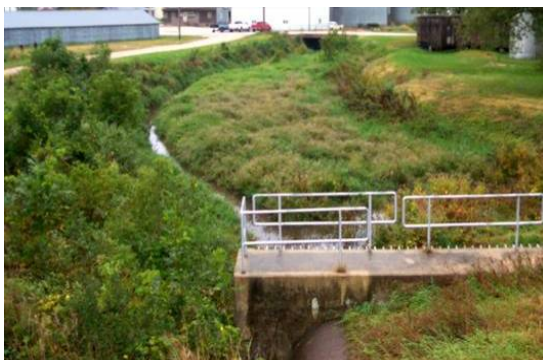
**Figure 2.56** *UNACCEPTABLE vegetation and sediment in interior drainage channel. (IA)*

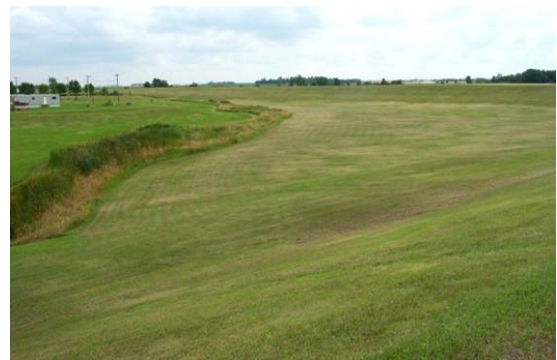
**Figure 2.57** *ACCEPTABLE interior ponding area and drainage ditch. (MN)*

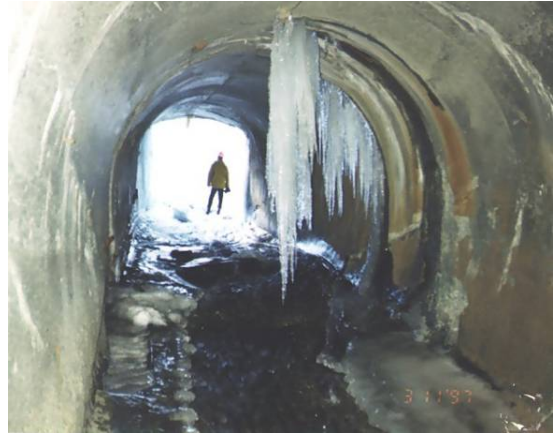
**Figure 2.58** Concrete drainage tunnel. (AK)

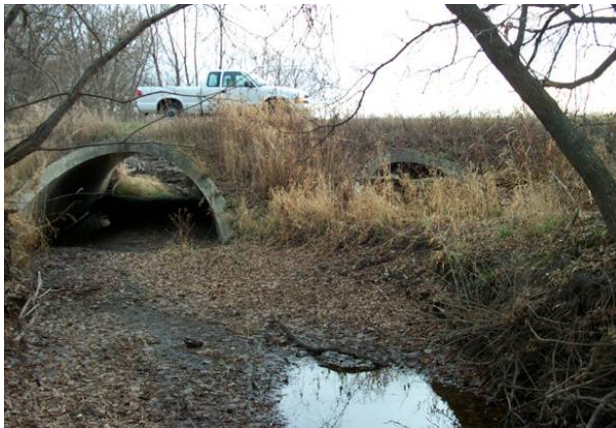
**Figure 2.59** The culvert on the left is Minimally Acceptable with sediment accumulation within the culvert. The culvert on the right is totally unacceptable with 2/3 of its flow capacity reduced by sediment and debris. This project was rated as UNACCEPTABLE because of the reduced flow capacity of the culverts. (MN)

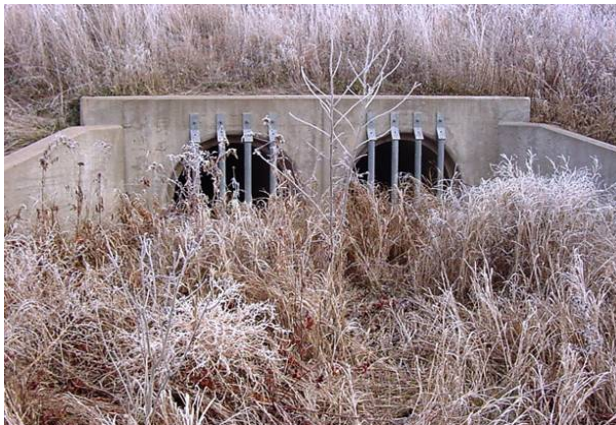
**Figure 2.60** MINIMALLY ACCEPTABLE, vegetation blocking the concrete culvert must be removed. (KS)

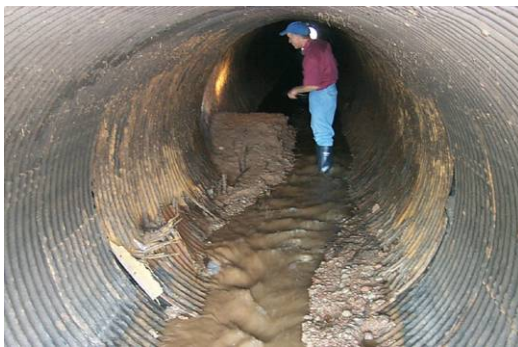
**Figure 2.61** *UNACCEPTABLE, Failing corrugated metal pipe. DO NOT WALK INTO A FAILING CULVERT LIKE THIS. This section has actually separated, allowing the surrounding soil to enter the pipe and the overburden to collapse. This sponsor was denied rehabilitation assistance due to this maintenance deficiency.*

One significant maintenance item in many levee systems involves the repair and replacement of corrugated metal pipes (CMPs). Many levees all over the country were constructed with corrugated metal pipes to transport interior drainage, because CMP was one of the cheapest and most reliable materials available at the time. When the levees were constructed, the engineers designed them for an established design life (usually no more than 50 years), and since CMP was predicted to last for design life of the project, it was the material of choice for many drainage culverts. However, with many of the levees around the country at or beyond the design life of the CMP, it becomes critical that the pipes are inspected frequently and thoroughly, and replaced as needed. Remember that even if a CMP looks OK on the inside, the outside of the pipe may be very corroded and weak. Interior and exterior rust, reduction in metal thickness, joint separation, holes, and settlement, have all lead to the failure of the culverts. When a CMP fails during a flood, not only does the culvert cease to function as necessary, but material from the levee collapses to fill in the void, leaving a low spot in the crown of the levee. This low spot can quickly lead to a breach in the levee and the flooding of the protected area.

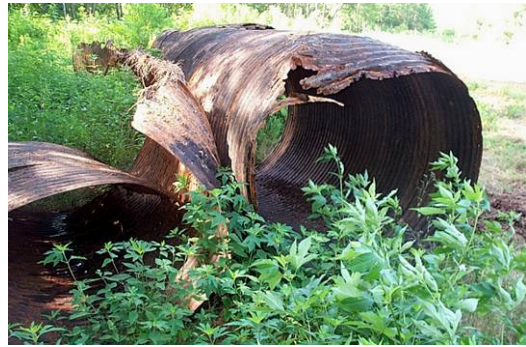
**Figure 2.62** *Pieces of the same pipe, once removed from the levee. Note that while much of the pipe may have appeared to be in good condition from the inside, the outside was extremely corroded. The public sponsor attempted to patch the pipe the first year, but when it failed again, the entire CMP was replaced.*

In some cases, a decaying CMP may temporarily be maintained by lining the pipe with an appropriate plastic liner or by patching it in various ways, but these are only temporary solutions and the pipe will eventually need to be replaced as part of the ongoing maintenance of the project. Because of this, you need to budget for the replacement of the pipes as their design life comes to an end. If it is noted during an inspection that a CMP culvert is Minimally Acceptable and the levee becomes damaged during a flood as a direct result of the failure of the CMP, then the Corps will deny post flood rehabilitation assistance for the repair of this damage. The maintenance and replacement of these pipes is considered to be part of the ongoing maintenance of the project and is therefore the responsibility of the public sponsor.

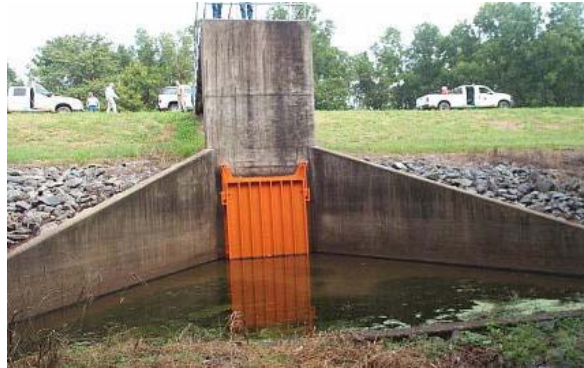
**Figure 2.63** *ACCEPTABLE culvert gate. (LA)*

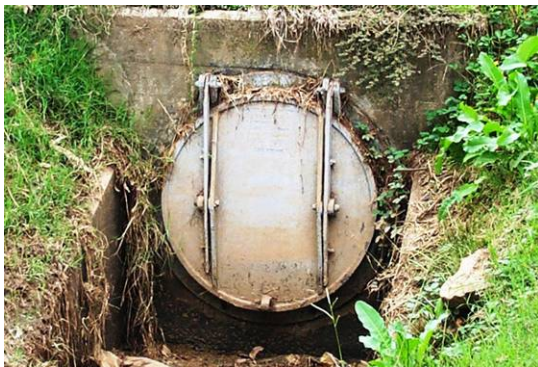
**Figure 2.65** *UNACCEPTABLE vegetation around flap gates in earthen levee. (OK)*

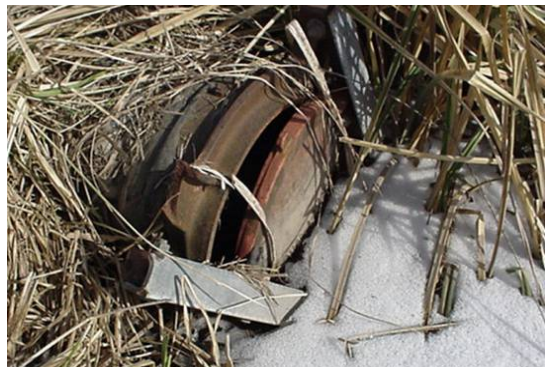
**Figure 2.66** *UNACCEPTABLE flap gate in earthen levee. (Broken hinge and vegetation growth.) (MO)*

All flap gates, slide gates, and other gate systems need to be inspected and lubricated at least once a year just before the flood season. If gates aren't seated properly, water will flow back through the drainage structure during high water. During the inspection, all gates should be manually operated, and any debris or obstructions removed. All gate seats should be checked and the

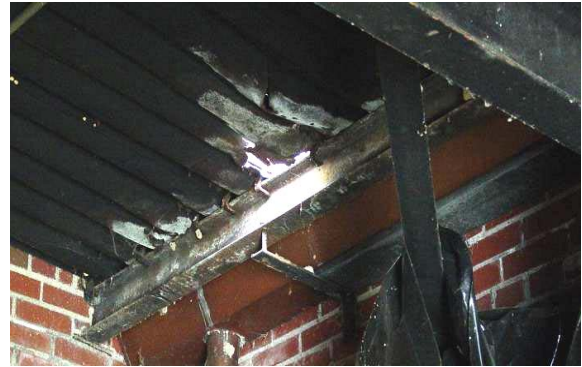
**Figure 2.67** Hole in roof of pumping station. (IL)

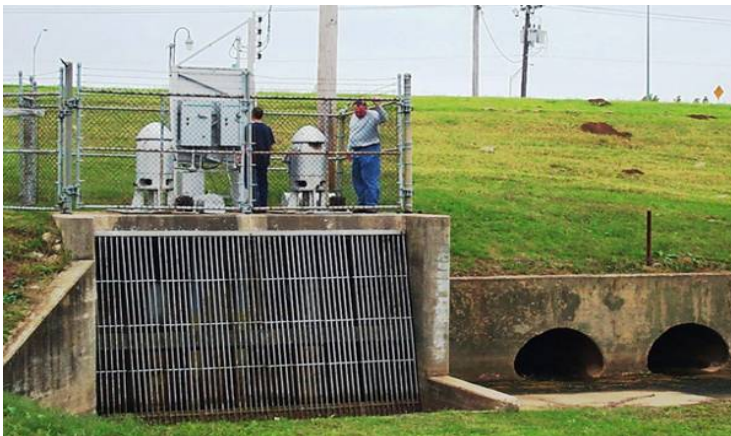
**Figure 2.68** Pump station beside earthen levee. (OK)

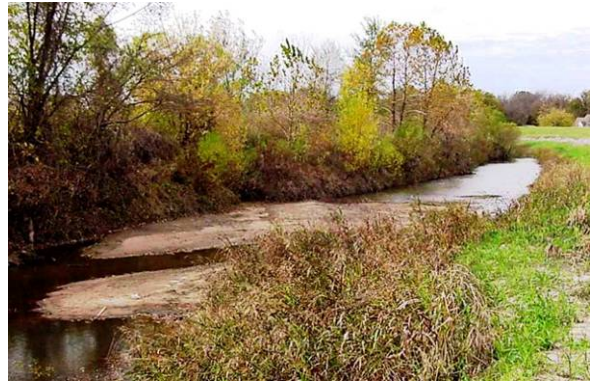
**Figure 2.69** *UNACCEPTABLE* vegetation in channel and sediment shoaling. (OK)

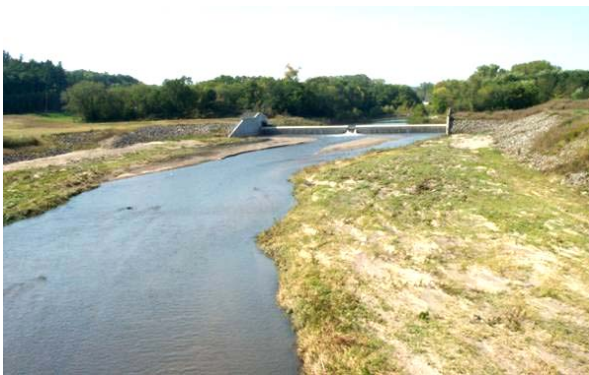
**Figure 2.70** *UNACCEPTABLE* channel shoaling below a control structure. The original channel bottom extended all the way to the riprapped banks. There is an estimated 2-3 feet of sediment in the channel, mostly from upstream field erosion and highway construction. (MN)

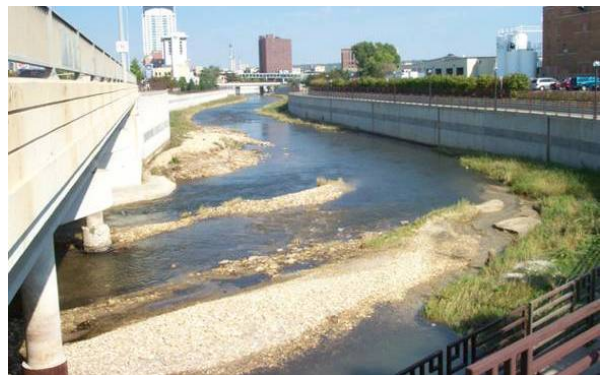
**Figure 2.71** *MINIMALLY ACCEPTABLE* shoaling within a concrete lined channel. (MN)

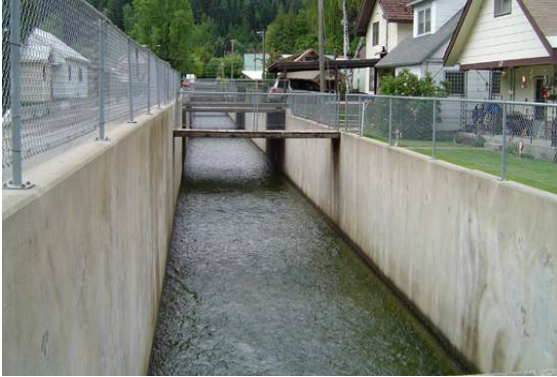
**Figure 2.72** *ACCEPTABLE* concrete lined flood control channel. (ID)

Concrete lined channels should be kept clear of debris, sediment, and vegetation. The concrete, flap gates, and other structures must be inspected annually and maintained as described in previous sections of this chapter. Sample maintenance and inspection activities may include (but are not limited to) clearing the sediment, vegetation, and debris; replacing joint seals as needed, and repairing damage to the concrete.

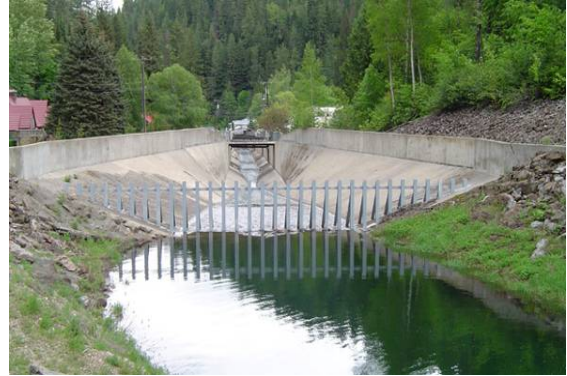
**Figure 2.73** *ACCEPTABLE* intake structure upstream of the concrete channel. (ID)
